## Holiday Inn Leeds - Brighouse

www.ihg.com/holidayinn/hotels/gb/en/brighouse/leebh/hoteldetail (https://www.ihg.com/holidayinn/hotels/gb/en/brighouse/leebh/hoteldetail) and the sum of the sum ofGuide Last Updated: 13/02/2018

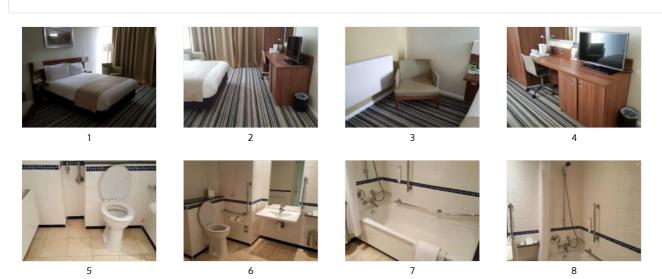
- The colour contrast between the external hotel room door and wall is poor.
- The colour contrast between the internal hotel room door and wall is poor.
- The colour contrast between the hotel room walls and floor is good.
- The colour contrast between the external ensuite door and wall is fair.
- The colour contrast between the internal ensuite door and wall is poor.
- The colour contrast between the ensuite walls and floor is fair.
- The colour contrast between the drop down rail(s) and wall is good.
- The colour contrast between the wall-mounted grab rail(s) and wall is good.
- The contrast between the wash basin wall-mounted grab rail(s) and wall is good.
- The colour contrast between the bath wall-mounted grab rails and wall is good.
- The toilet seat colour contrast is poor.
- The lighting levels in the room are low.
- The lighting levels in the ensuite are good.
